VAL MORITZ VILLAGE

FEASIBILITY REPORT ON INDIVIDUAL ONSITE WASTEWATER SYSTEMS FOR FILING 2, BLOCK 7

**Prepared by:
Shannon Engineering, Inc.**

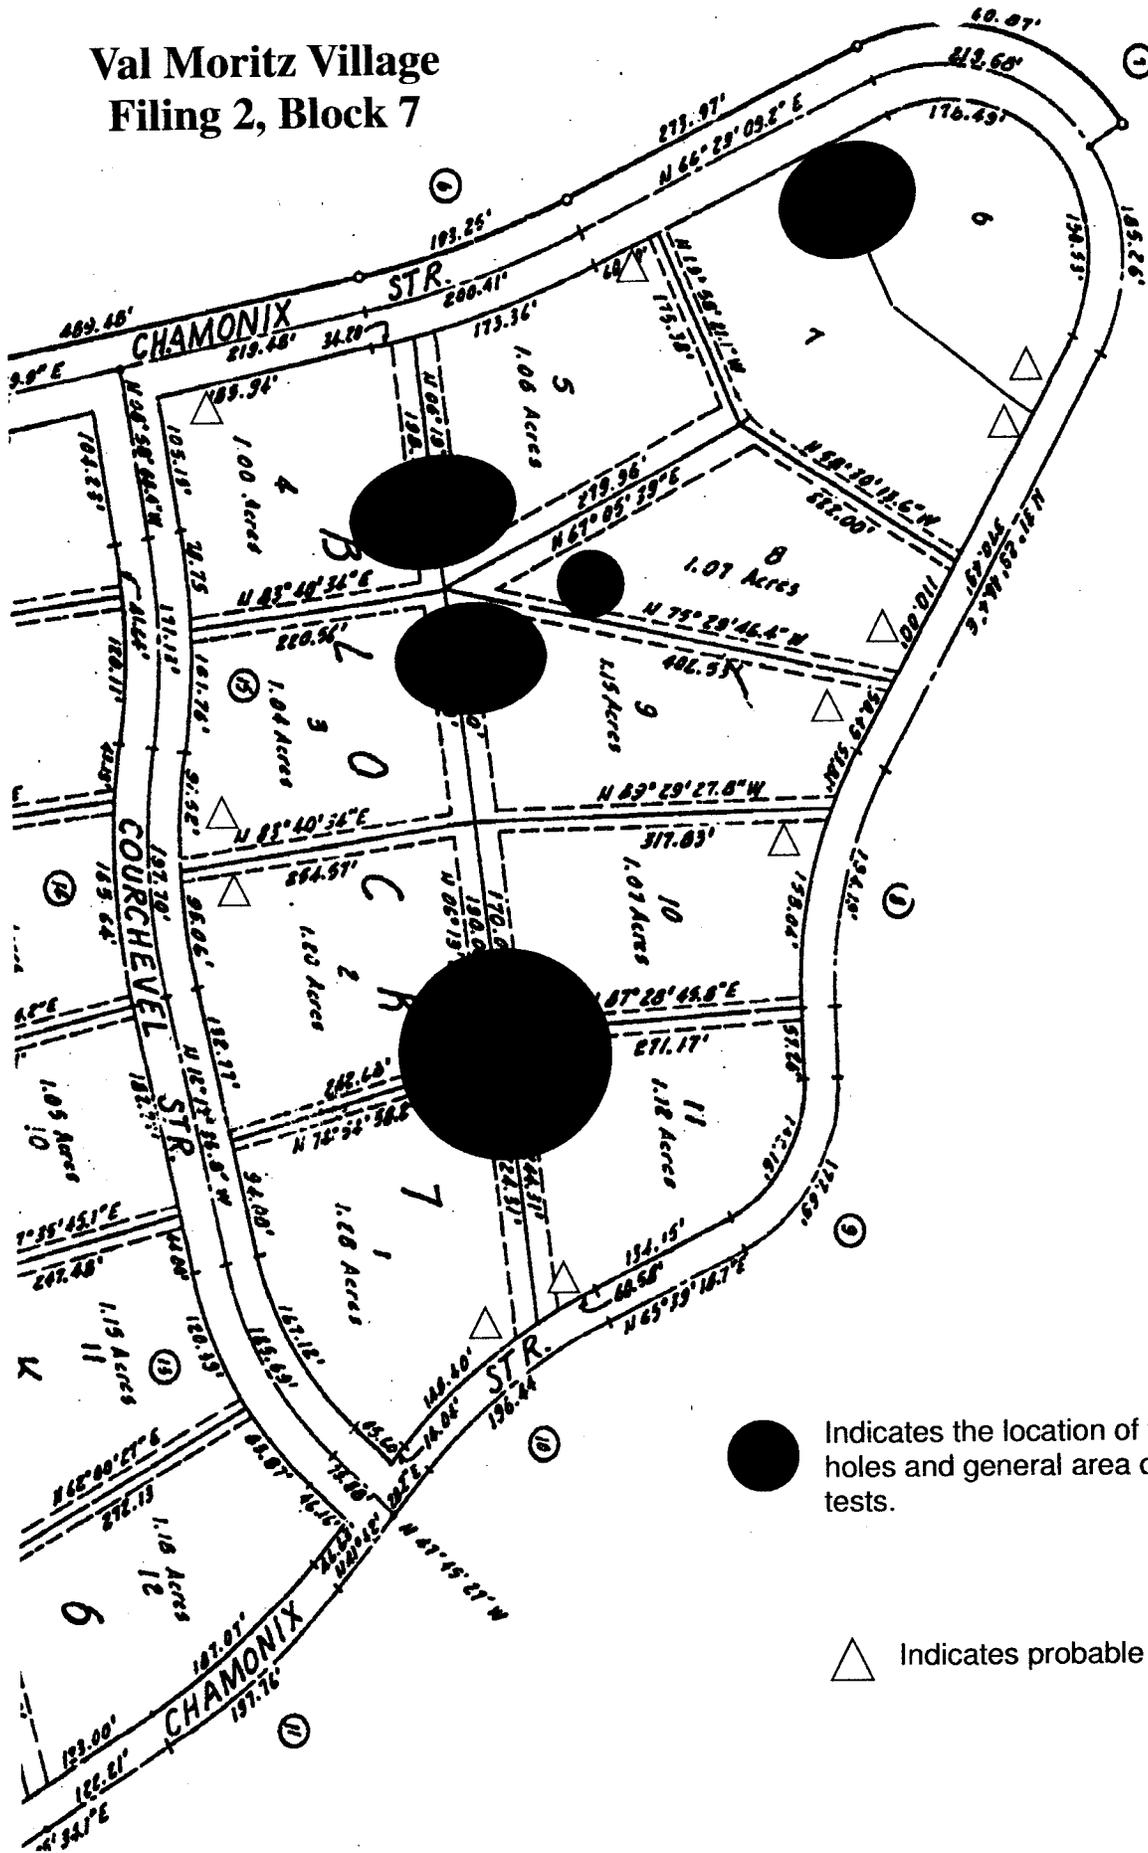
Val Moritz Village Filing 2, Block 7

Indicates the location of the soil profile holes and general area of percolation tests.

Indicates probable well locations.
