VAL MORITZ VILLAGE

FEASIBILITY REPORT ON INDIVIDUAL ONSITE WASTEWATER SYSTEMS FOR FILING 2, BLOCK 6

**Prepared by:
Shannon Engineering, Inc.**

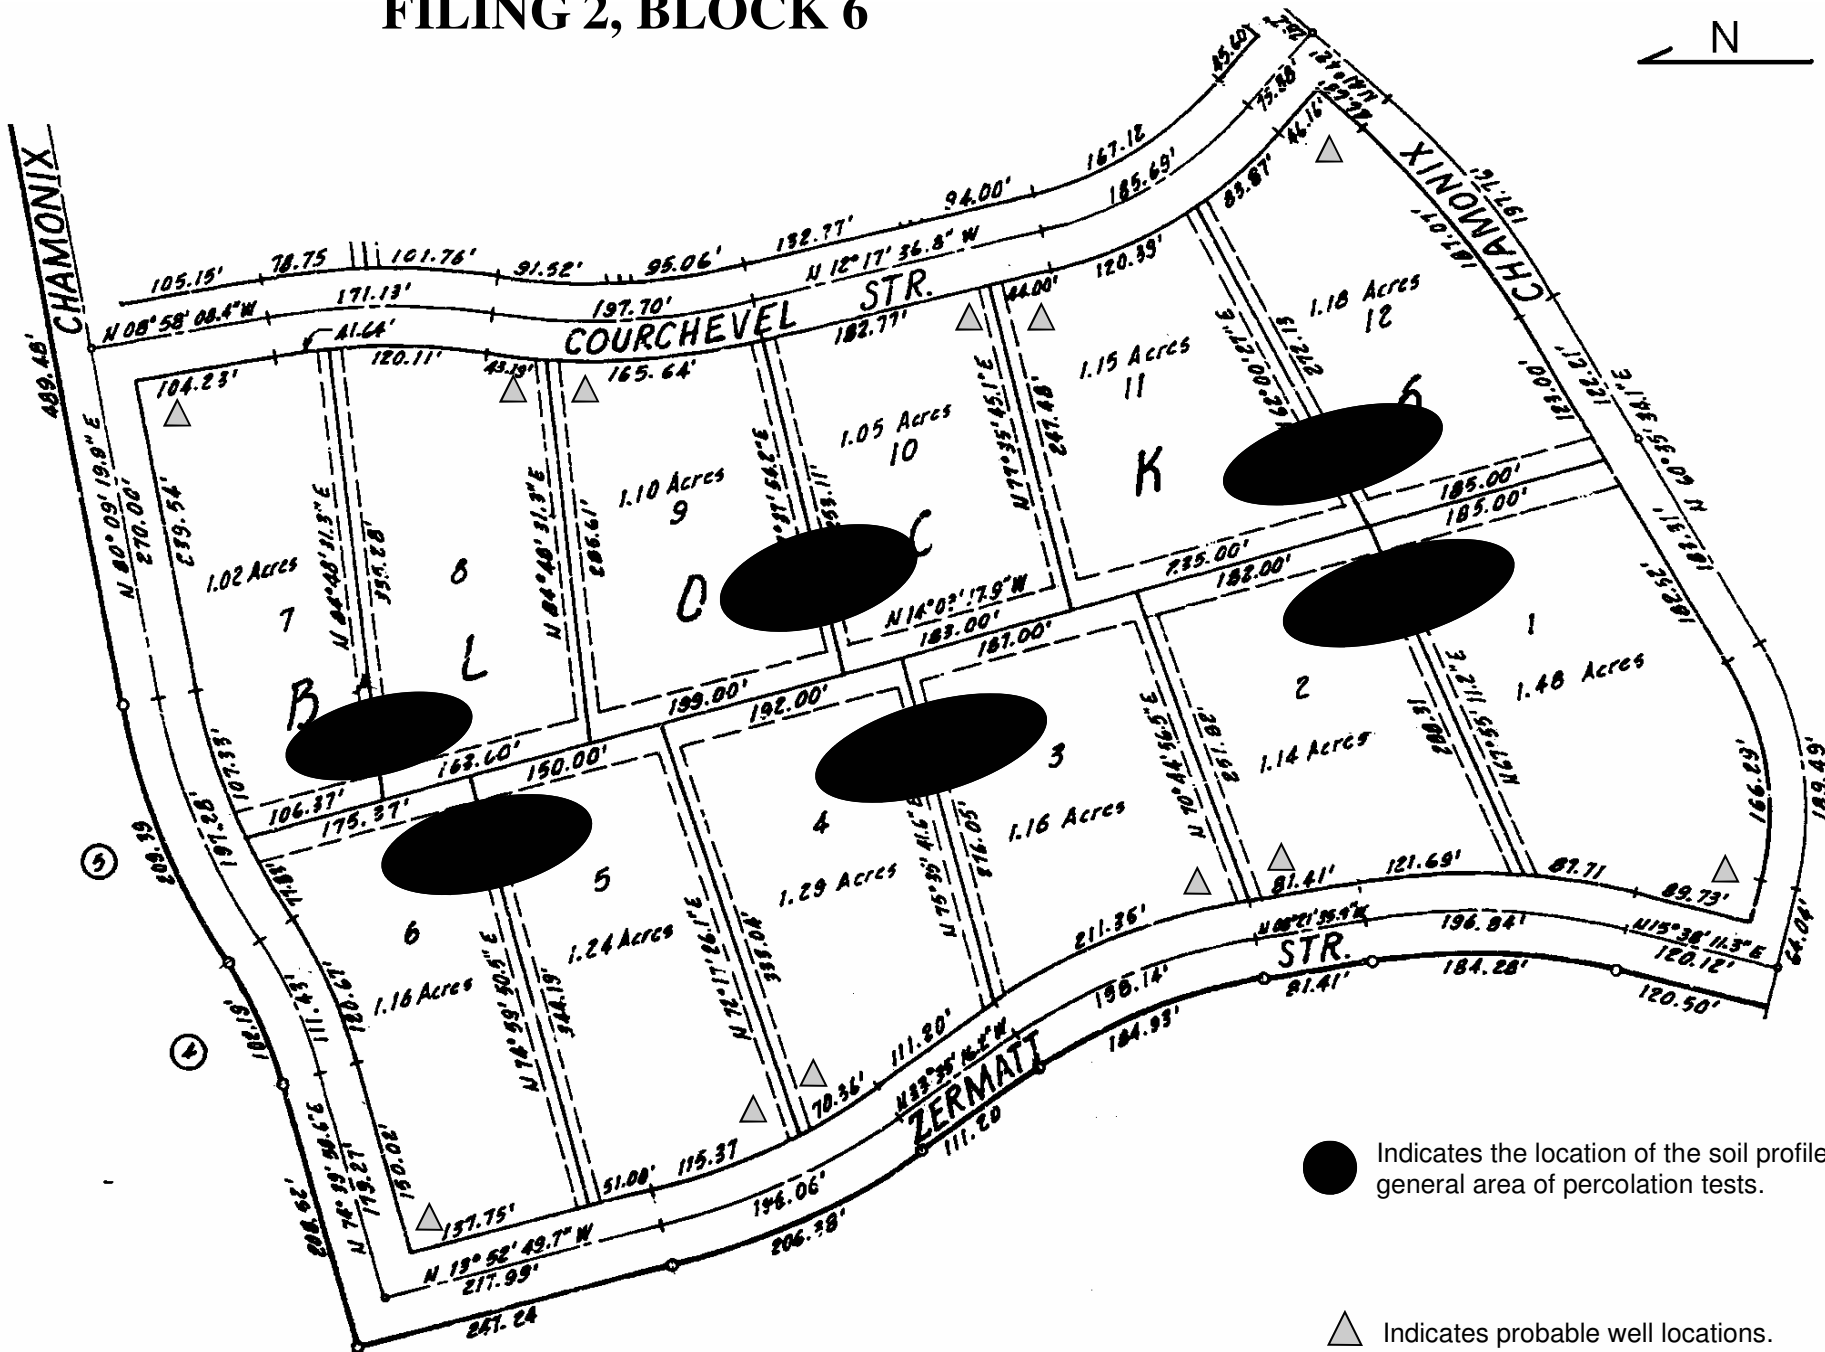
VAL MORITZ VILLAGE FILING 2, BLOCK 6

● Indicates the location of the soil profile holes and general area of percolation tests.

▲ Indicates probable well locations.
